NAVAL AVIATION SAFETY CENTER

Subj: Aircraft Accident Report

1. AIRCRAFT ACCIDENT BOARD APPOINTED BY Commanding Officer FITRON EIGHTY FOUR		2. SERIAL NO. 1-66A	3. STG (LOCAL) OF MISHAP 171530QJUN	4. MODEL AIRCRAFT F4B	5. BUREAU NUMBER 152976
6. TO: Commander, Naval Aviation Safety Center		7. LOCATION OF MISHAP CVA-62 LAT 18-03N LON 64-38W		8. DAMAGE ALFA	
9. VIA: CVW-7 CO, USS INDEPENDENCE COMCARDIVVSIX COMSECONDEFLT COMNAVAIRLANT		10. TIME OF DAY DAY	11. TIME IN FLIGHT 0407	12. FLIGHT CODE 127	
		13. CLEARED FROM CVA-62	14. TYPE CLEARANCE VFR		15. AIRSPEED 230 Knots P
					16. A/C WEIGHT 38,000 lbs.
17. BRIEF DESCRIPTION OF MISHAP Uncontrolled collision with water following crew ejection		18. ELEVATION AT TIME OF MISHAP 1200'		19. TERRAIN 1200'	
20. LIST MODELS, BUNS, REPORTING GUARDIAN AND DAMAGE CLASSIFICATION OF ANY OTHER A/C INVOLVED (Complete OPNAV Form 3750-1 for each A/C)					
NONE

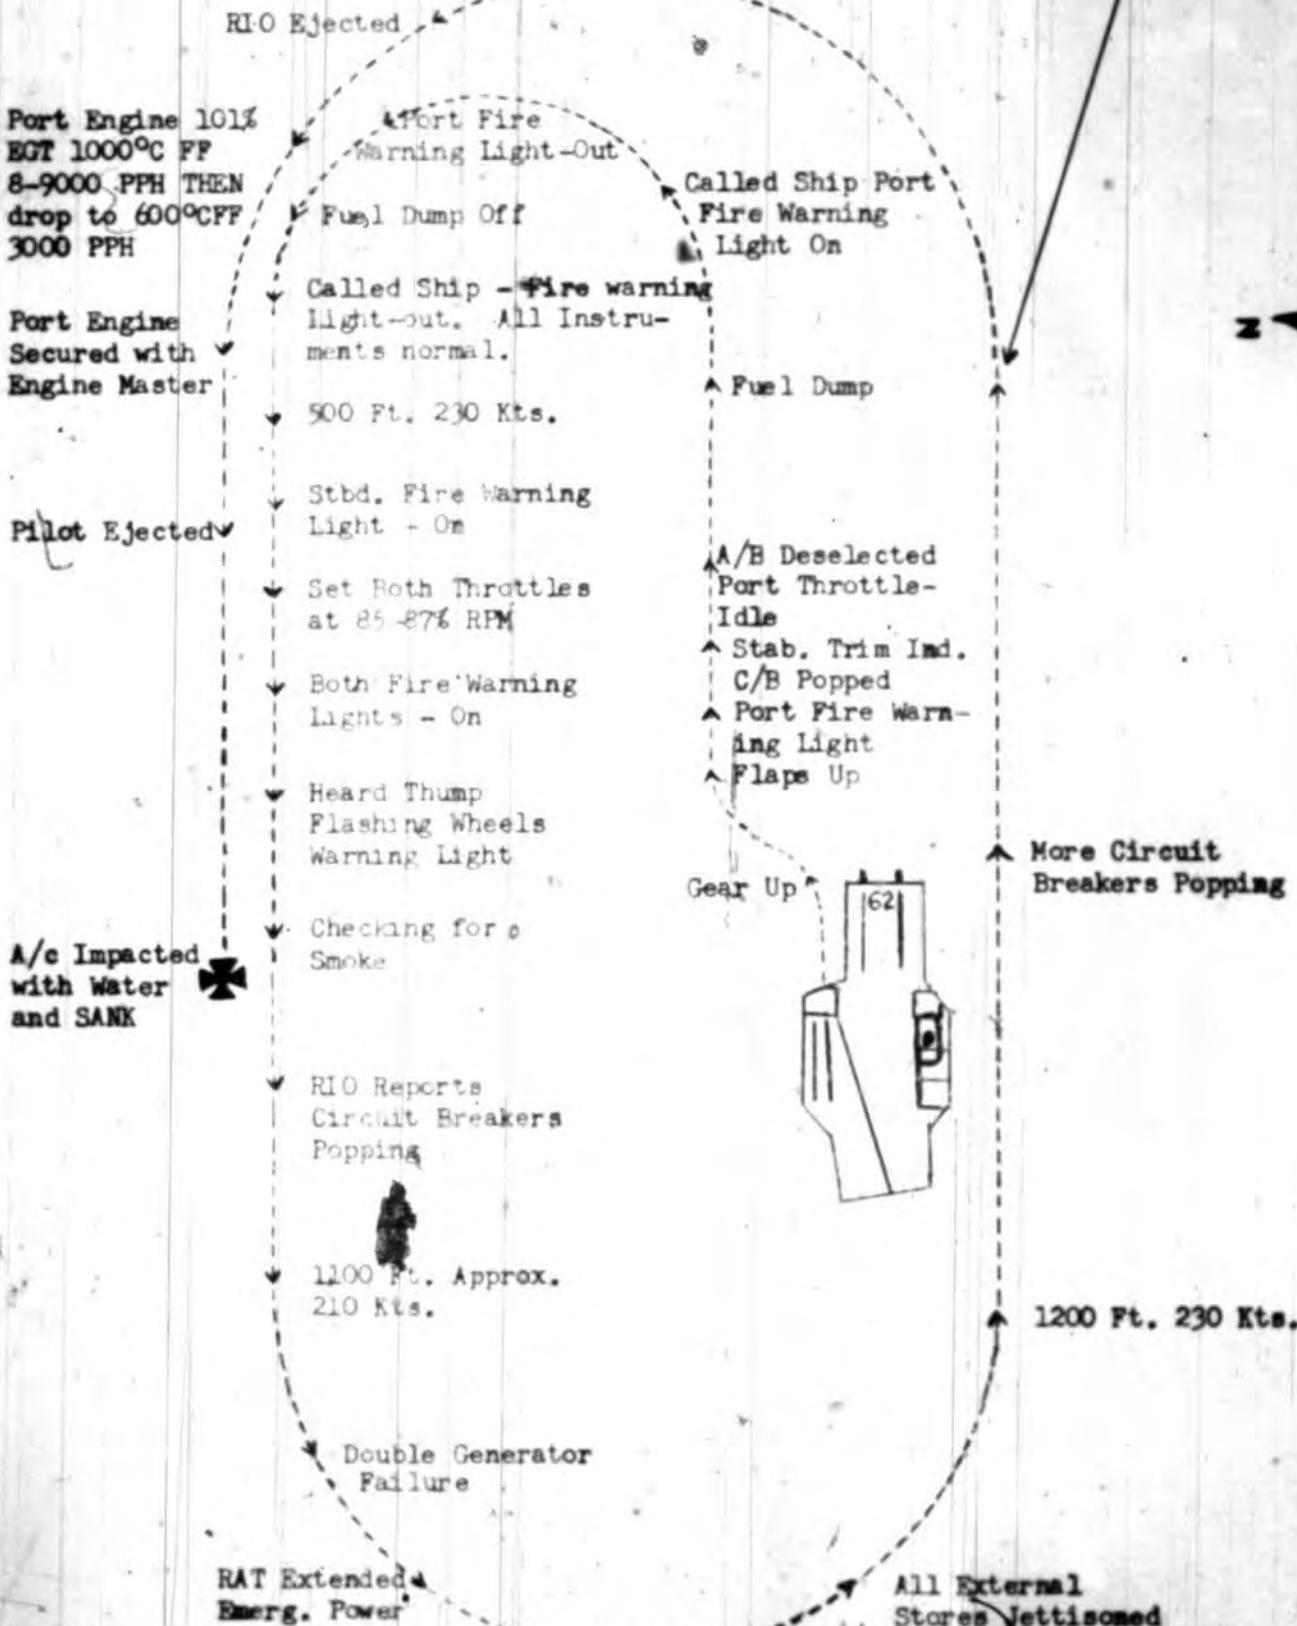
SPECIAL HANDLING REQUIRED IN ACCORDANCE WITH PARAGRAPH 66, OPNAVINST P3750.6E
ENCLOSURE 8 TO C.O., VR-84, AAR SER 1-66A

**Indications of Fire
Observed by Witnesses**
